Special sewer rehabilitation in Ghent

A construction site against a historical backdrop was the challenge for the team from Kumpen NV and Brandenburger Liner GmbH & Co. KG in the Belgian city of Ghent. At the “Korenmarkt”, the historical centre of Belgium's third-largest city, two liners needed to be installed. The challenge: the not very “classical” form of the sewer which required a special solution. And then there was the location: The pipes to be rehabilitated underpass the tram line next to a church.

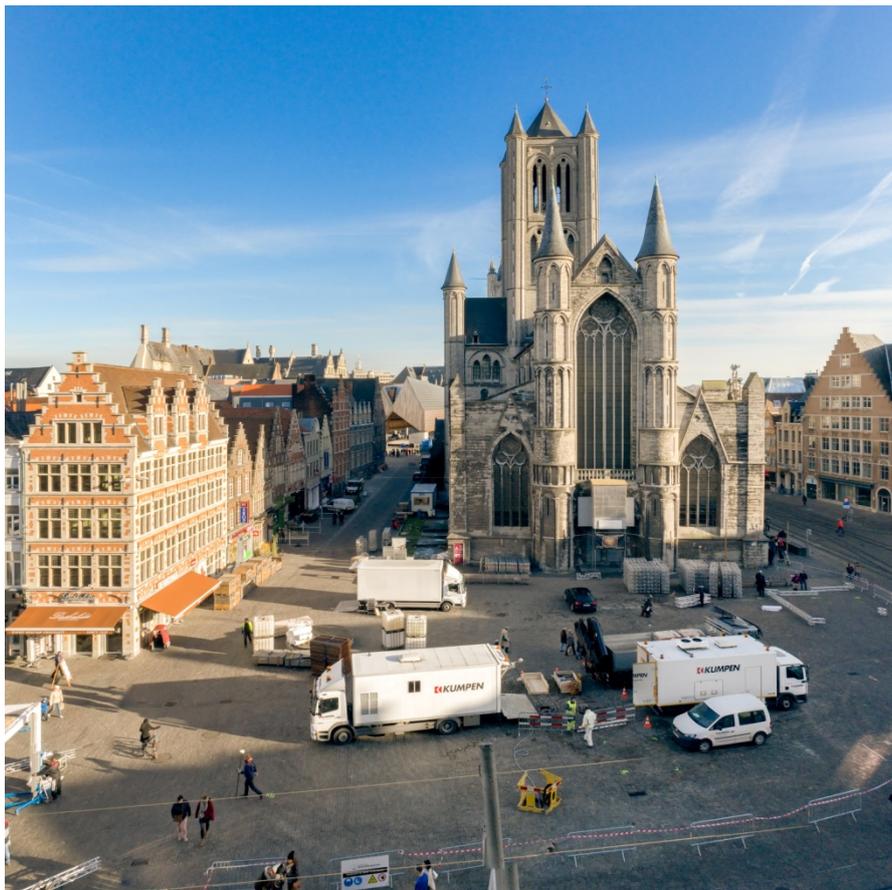
The Belgian city of Ghent has 250,000 inhabitants. The “Korenmarkt”, the historical centre of the city, is a meeting point for the locals, students and tourists. The Gothic St. Michael's church, dating back to 1440, is also located in this quarter. The employees from Kumpen NV and the Brandenburger Liner company were tasked with the rehabilitation of a sewer right next to it; underneath a tram line. This rehabilitation became necessary because the old pipe had lost wall thickness massively due to sulphuric acid corrosion. The pipe featured a box profile with the dimensions 400 millimetres x 1200 millimetres.

Due to this rather unusual width of 1200 millimetres, no single liner could be drawn in by itself, because this would have a negative effect on the UV radiation: The radiation would cure the liner only at the apex and base; that is at the top and bottom. The side walls would thus not receive sufficient UV light and would remain “soft”. The goal of the rehabilitation would not be achieved. Even a slower “retraction” of the light chain would have been problematic, for instance because the inner foil would melt in this case and remain adhered to the surface of the liner.

To achieve an optimal rehabilitation result, a special solution needed to be found: Not one, but two liners with the dimension DN 550 (8.4 millimetres with a length of 25 metres) were to be drawn in next to each other.

Thus work started at the construction site at 7 in the morning. The pipe liners were drawn into the box profile after and next to each other. For both, the installation team first put in the packers which seal the liner ends. Simultaneously the tubes were slowly calibrated with two condensers to achieve an accurately fitting result.

While the one liner was still pressurised, the other one was already being cured. The curing of the second one followed after that. Construction was nearly completed around 3 pm by the removal of the packers and the extraction of the inner foil. Only the hollow spaces needed to be filled finally so that the old pipe floor system in combination with the liner could durably fulfil the static conditions.

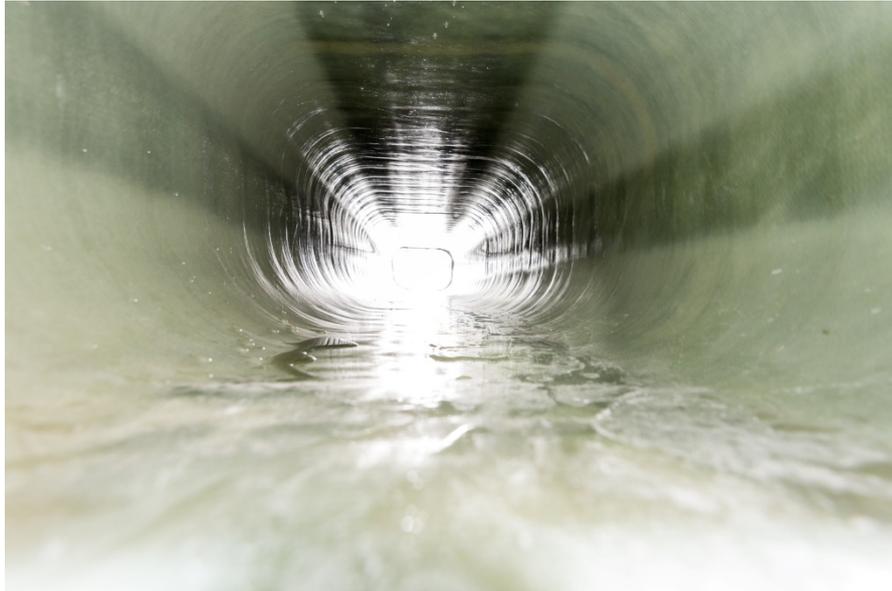
Liners made by Brandenburger have a high dimensional strength thanks to the patented wrapping technology and yet remain especially soft and pliable. The specially matched components developed for the company allow for an easy manoeuvrability of the liner as it is drawn into the sewer.

Additionally they feature a certain rigidity as soon as the liner is pressurised.

This makes it possible to insert the UV light chain easily into the liner without it collapsing.

These were the reasons why the box profile could be rehabilitated so successfully with two liners in Ghent.
